Technical Memorandum 79665

Ultraviolet Effects on Conductive Coated Coverglasses

James A. Bass and Luther W. Slifer, Jr.

NOVEMBER 1978

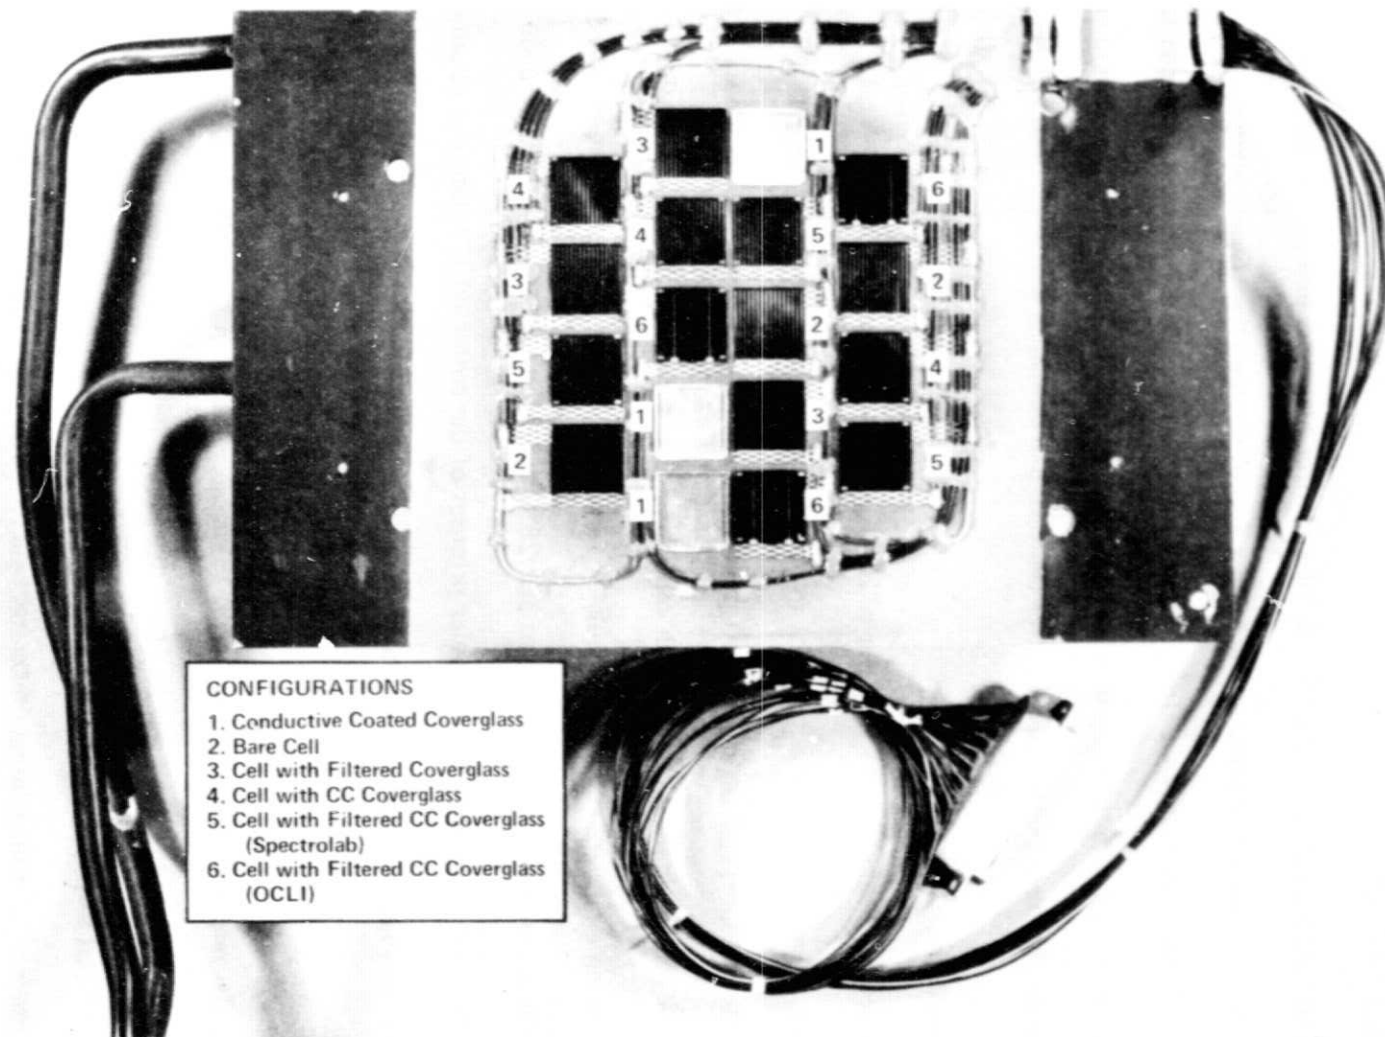
Figure 1. Testplate With Samples Mounted

The 18 samples were mounted on a water-cooled copper plate as shown in Figure 1. The cell assemblies were bonded in place using RTV-566 adhesive, while the coverglasses were held in place, without bonding, using a brass holder which overlapped onto the glass approximately 1 mm on each edge. For each configuration the samples were distributed on the plate so as to reduce any systematic effects such as beam non-uniformity.

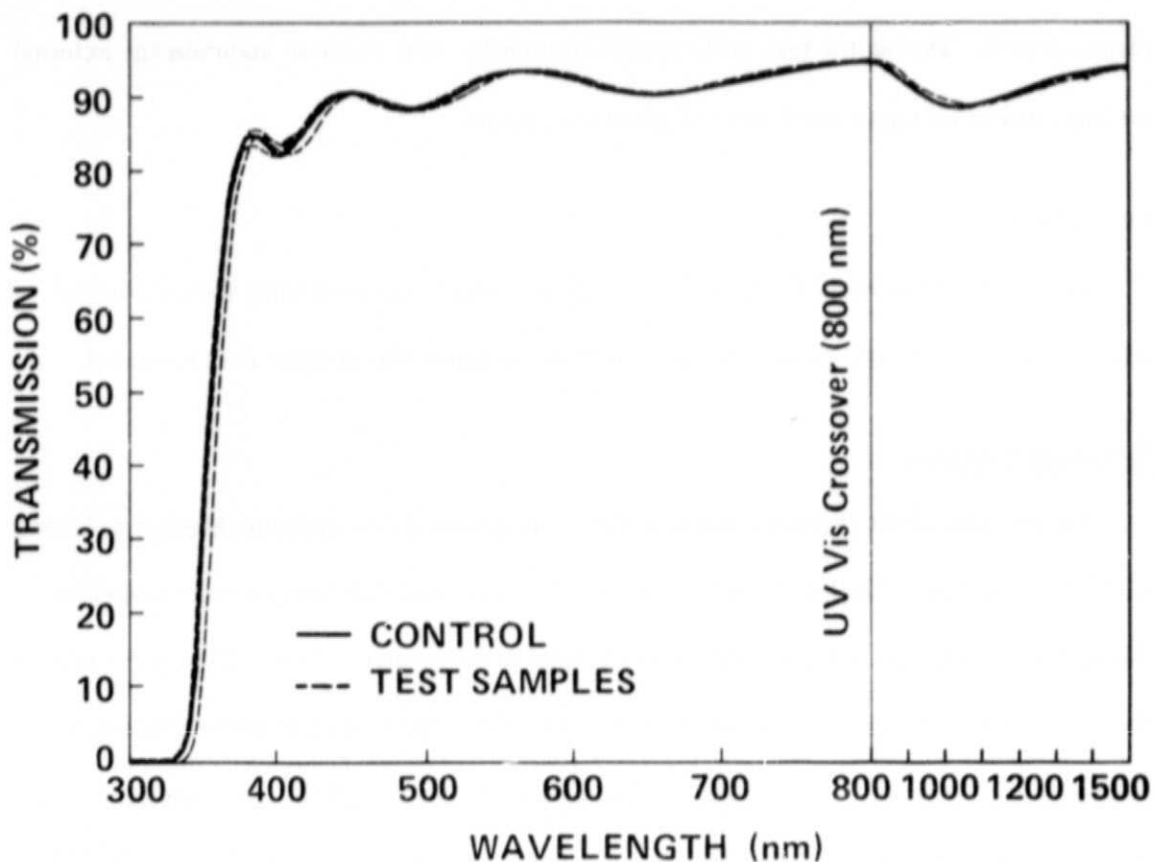
Figure 2. Pre-test Transmission of Conductive Coated Coverglasses

The pre-test transmission curves for the control sample and the three test samples are shown in Figure 2. It can be seen that there is a high degree of similarity for the curves. Because the post-test curves were almost identical, limitations, such as drift, non-linearity, etc., of the spectrophotometer made the data difficult to interpret. However, by reading the difference between the control coverglass and the tested sample both before and after the UV exposure and calculating the changes, it was possible to identify

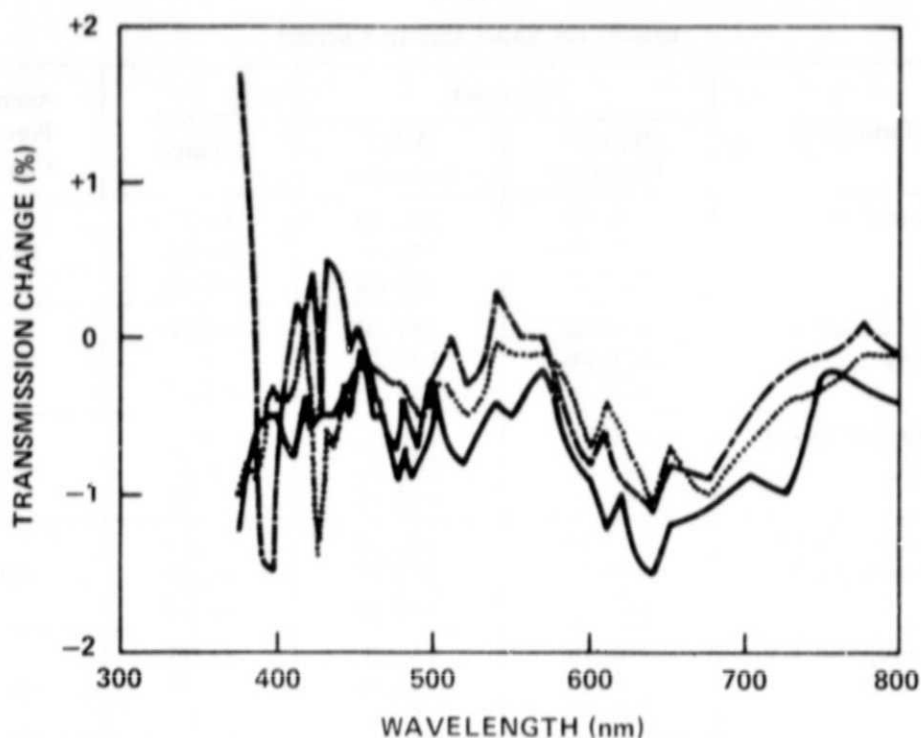
Figure 3. Net Change in Transmission for Three Samples. (Configuration 1.)

a definite, though small, loss in transmission. Results are shown in Figure 3. For wavelengths below 450nm, the transmission changes rapidly and this analysis technique tends to break down. That is, small wavelength shifts result in large transmission changes.

These, in turn can result in large difference errors. For wavelengths above 450nm, Figure 3 shows nominal degradation of the order of 0.5 to 1 percent.

1. State of the art conductive coated coverglasses are suitably stable for flight application insofar as ultraviolet effects are concerned.
2. Ultraviolet effects on the transmission of conductive coated coverglasses exposed to 5000 ESH resulted in a transmission loss of 0.5 to 1 percent.
3. The short circuit current loss for solar cell assemblies with conductive coated coverglasses is approximately 1 percent greater than for those with conventional coverglasses after exposure to 5000 ESH.

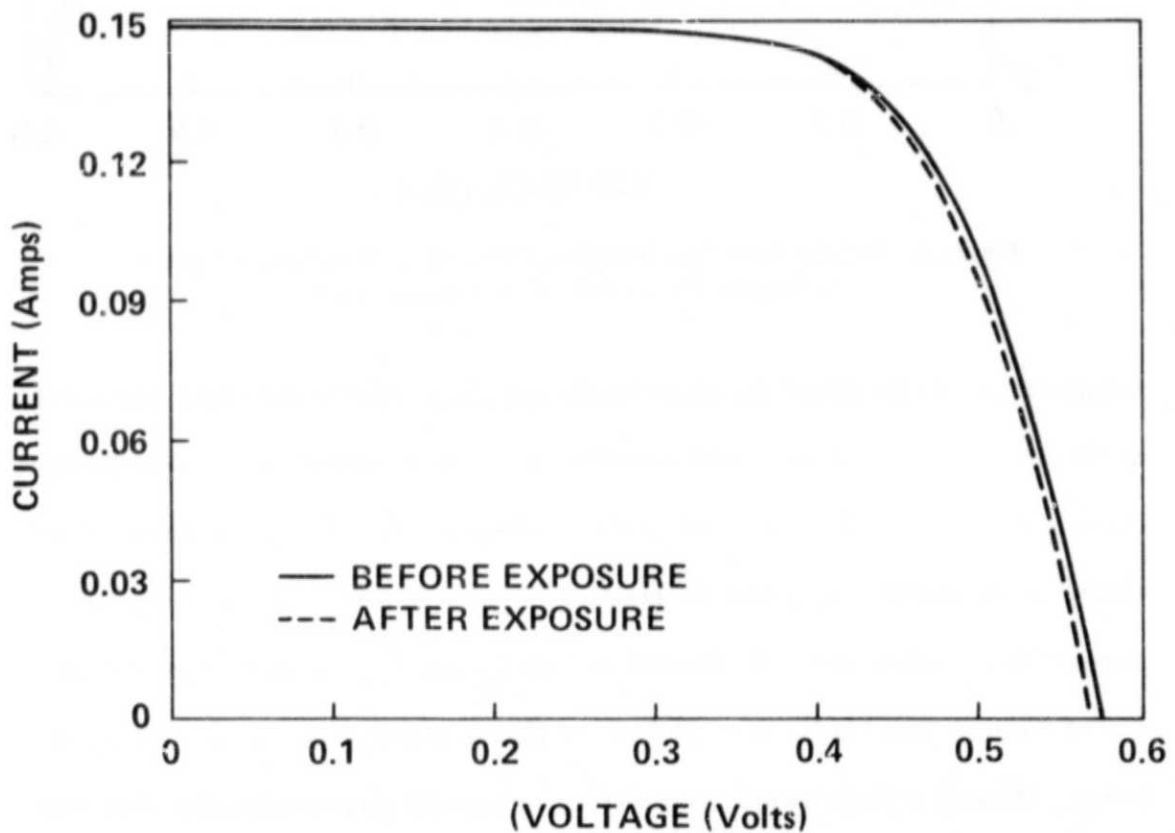
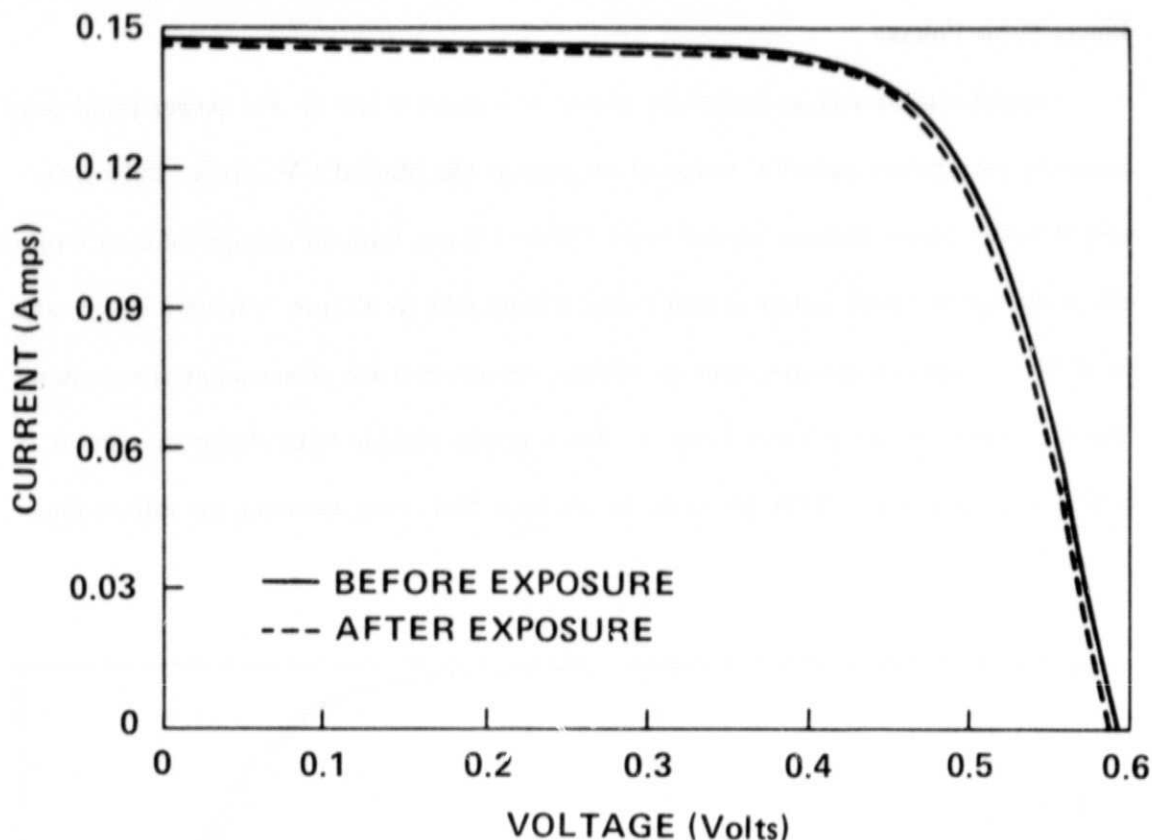
Typical current-voltage curves are shown in Figures 4 and 5. For power point comparisons, peak power points were found on each of the plotted I-V curves. Before the test the peak power voltages ranged from 428 to 473mv, with an average value of 444mv. After the test the peak power voltages ranged from 423 to 472mv, with an average value of 439mv. Hence, a nominal value of 440mv was selected for power point comparisons. These comparisons are given in Table 3. These results include both effects on current and effects on voltage. They are given to illustrate that, even assuming the effects on

Figure 4. Typical Electrical Output for Bare Spectrolab Cell. (Configuration 2.)

Figure 5. Typical Electrical Output for OCLI Cell, Conductive Coated Coverglass With Filter. (Configuration 6.)

voltage are due to the ultraviolet exposure, the combined effect is still small. The scatter of the data is generally determined by whether the common 440 mv, point is on the short circuit current side of the peak power point, in which case the change corresponds more closely to the change in I_{SC} ; near the peak power point, in which case the change corresponds to a combination of the changes in both I_{SC} and V_{OC} ; or on the open circuit side of the peak power point in which case the change results primarily from the change in V_{OC} . Because of these complicating factors, considerable caution should be exercised in drawing conclusions from the data in Table 3.
